Memorandum - Enforcement Confidential

Subj: NPDES Compliance Sampling Inspection
Municipal Separate Storm Sewer System (MS4)
City of Chelsea, MA

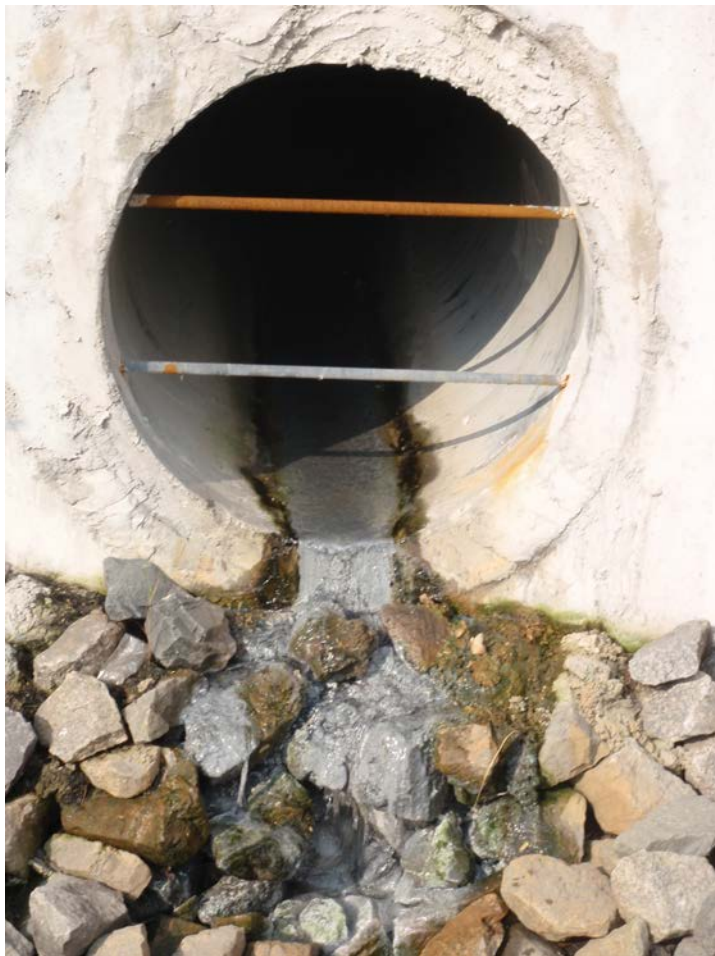
At approximately 8:40 hours EPA sampled an unnamed outfall (sample id "Mill2a") located approximately 50 yards west of "Mill2". This outfall is an approximate 24-inch concrete pipe in a concrete headwall and appeared to be of recent construction. EPA noted flow of approximately 3 gallons per minute, strong odor with a chemical edge, some suds on water surface, gray and cloudy water, significant (approximately twice amount during 26 May 2009 inspection) gray bacterial plaque within and beneath the outfall pipe. Using Hach brand test strips for ammonia and a Chemetrics K-9400 field kit for surfactants, EPA personnel processed a surface water sample collected at the location. Field kits indicated elevated levels of ammonia (>6.0 mg/l) and surfactants (0.75 mg/l) in the sample. A sample was collected and sent back to the EPA laboratory for enterococcus bacteria.

Photo 1: 7/29/09 8:40 AM. View of unnamed outfall and "Mill2a" sample location. Note gray bacterial plaque in bottom of outfall pipe and on rocks beneath pipe.

Following the inspection, Andy DeSantis notified, by phone and in a letter on 29 July 2009, Federal Realty Investment Trust, the owner of the adjacent property, of DPW's and EPA's observations and findings requesting that they take action to determine cause and eliminate discharge.

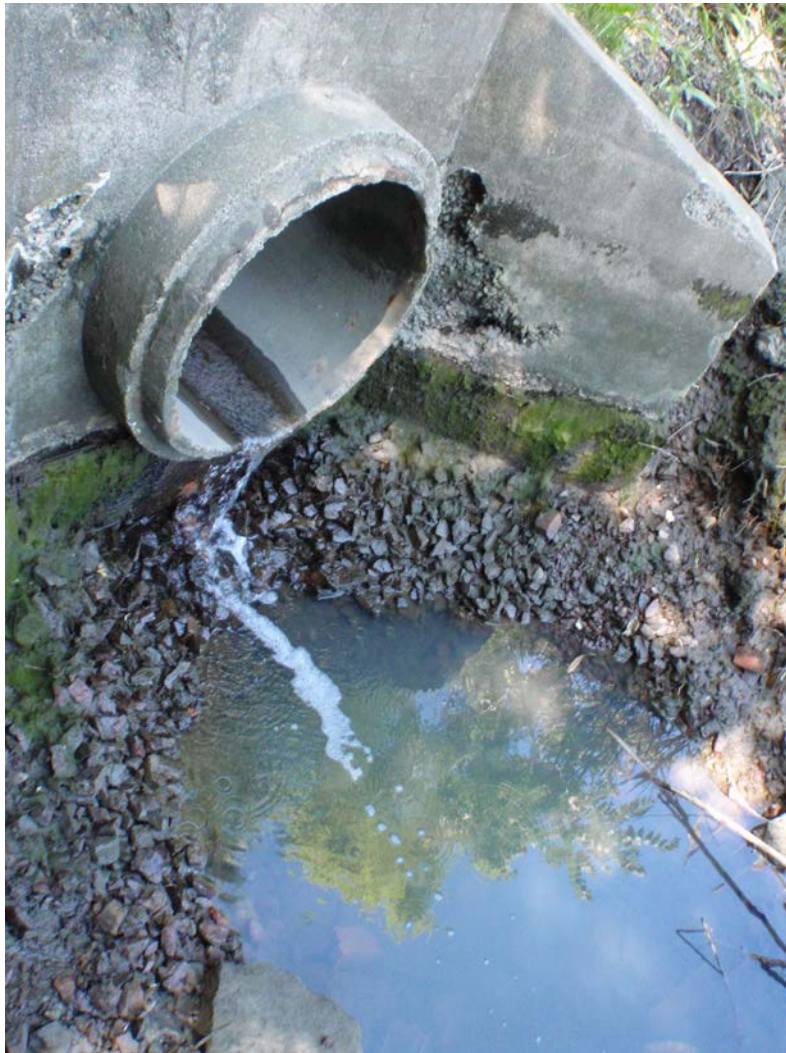
At approximately 10:06 hours EPA sampled the Gillooly Road outfall (sample id "Mill2"). This outfall is an approximate 30-inch concrete pipe. EPA noted flow of approximately 5 to 10 gallons per minute, a strong sewage odor, gray bacterial plaque in the outfall pipe, and a small amount of suds beneath the pipe in the receiving water. Using Hach brand test strips for ammonia and a Chemetrics K-9400 field kit for surfactants, EPA personnel processed a surface water sample collected at the location. Field kits indicated elevated levels of ammonia (3.0 mg/l) and surfactants (1.5 mg/l) in the sample. EPA personnel typically use 0.5 mg/l ammonia and 0.25 mg/l surfactants as threshold level screening concentrations, where sample results equal to or greater than these concentrations may be indicative of illicit discharges.

Photo 1: 5/26/09 10:05 AM View facing west – Gillooly Road outfall. Note gray bacterial plaque in bottom of outfall pipe and suds in receiving water. Sample "Mill2" collected at this location.

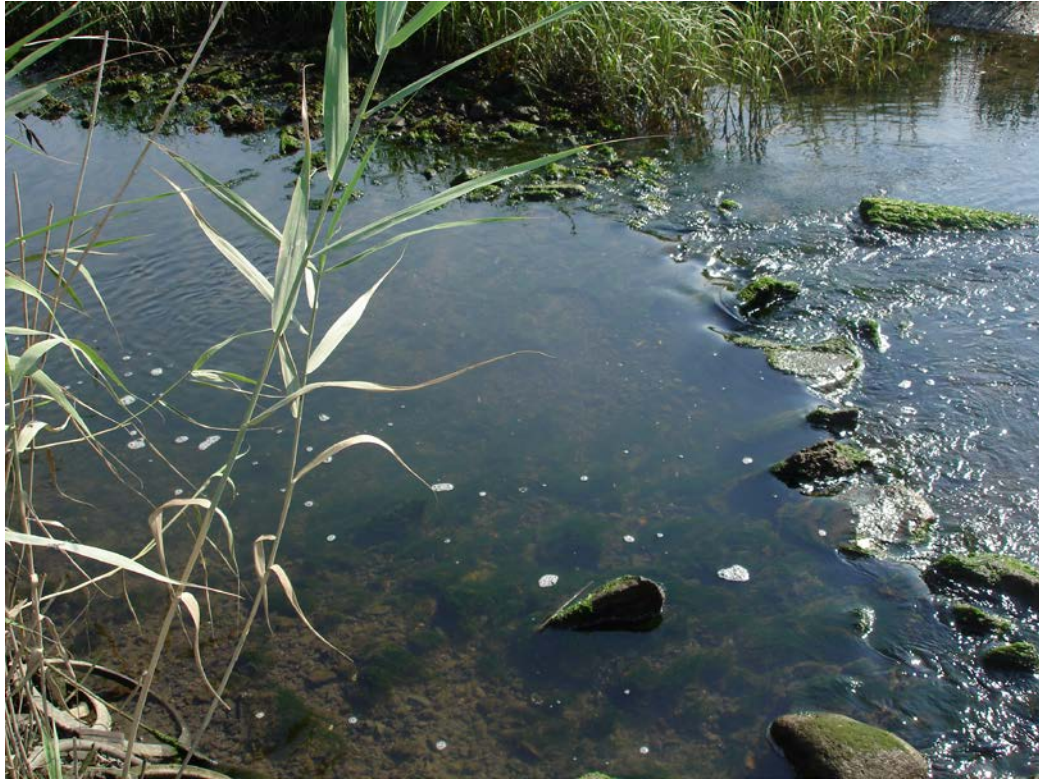
Photo 1: 7/6/11 0849 hrs. View of “MillCreek02” sample location, just upstream of Chelsea Commons outfall pipe (outfall pipe aka “Mill2A in EPA sampling efforts).

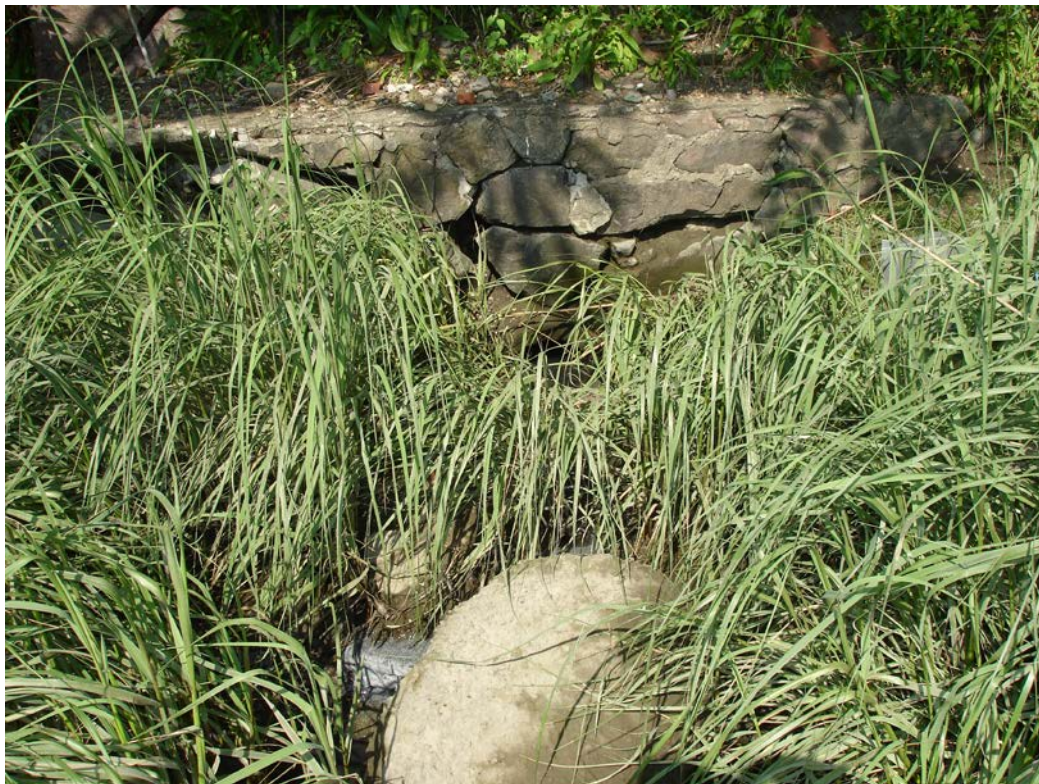
Photo 2: 7/6/11 0859 hrs. View of concrete outfall pipe and “CHEX06” sample location. Note gray bacterial growth in outflow from pipe.

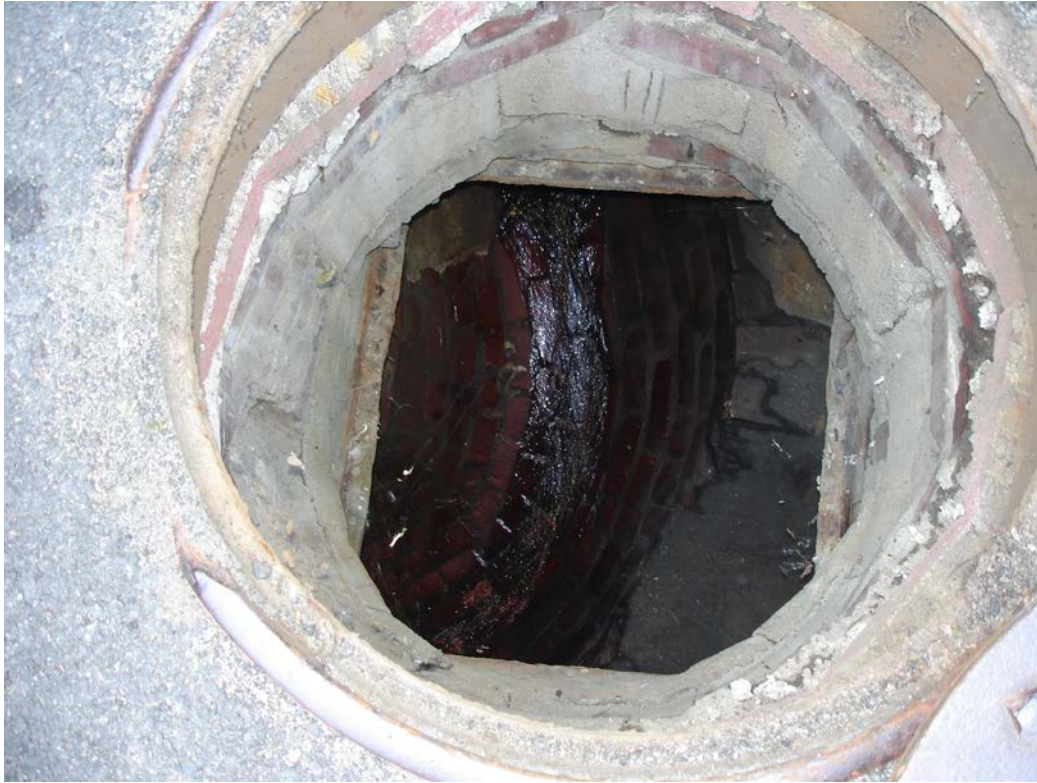
Photo 3: 7/6/11 0950 hrs. View of “WebAv” sample location, a drain access manhole on the east side of the intersection of Webster Ave and Revere Beach Parkway (Route 16).

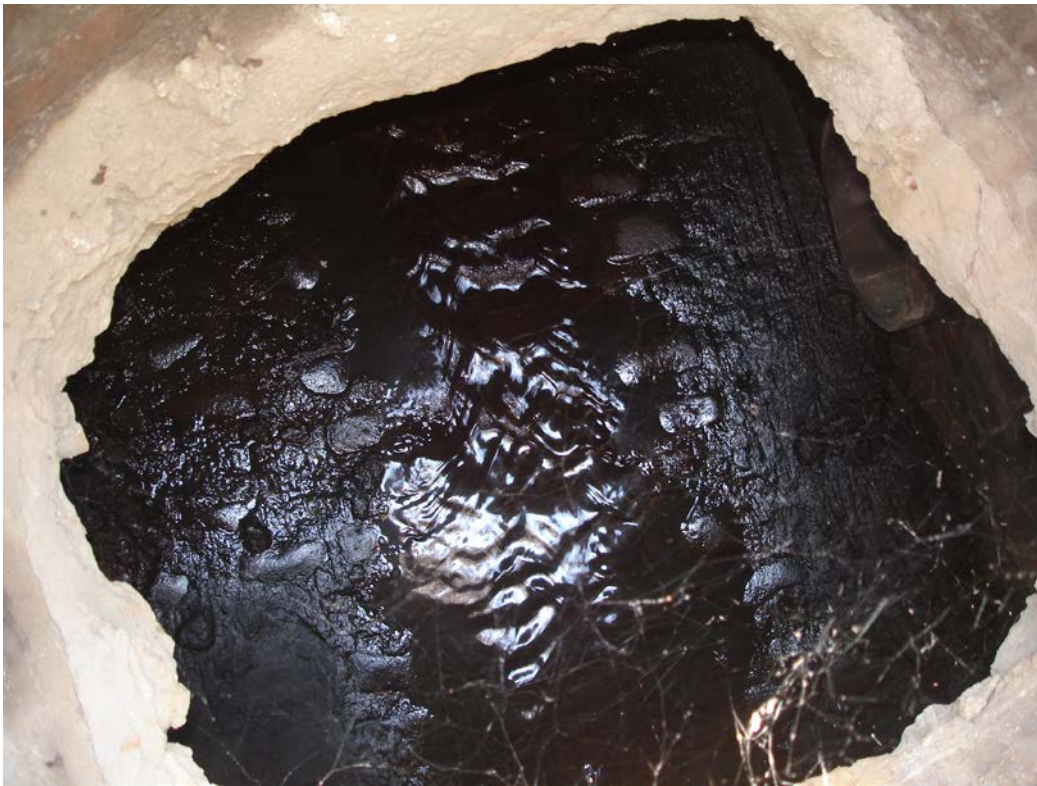
Photo 4: 7/6/11 1017 hrs. View of “Murray” sample location, a drain access manhole in Murray Street, approximately 100 ft south of Sagamore Avenue.

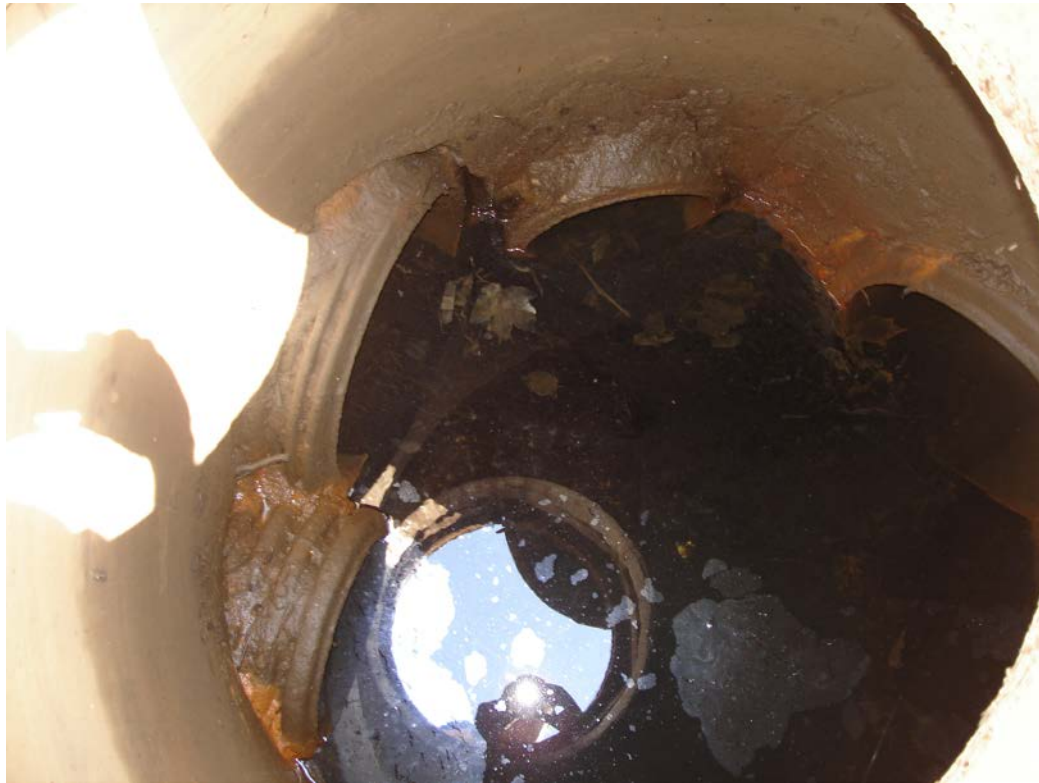
Photo 5: 7/6/11 1127 hrs. View of “RT1Ramp” sample location, a drain access manhole in the parking lot of the Chelsea housing authority approximately 50 feet east of Exeter Street.

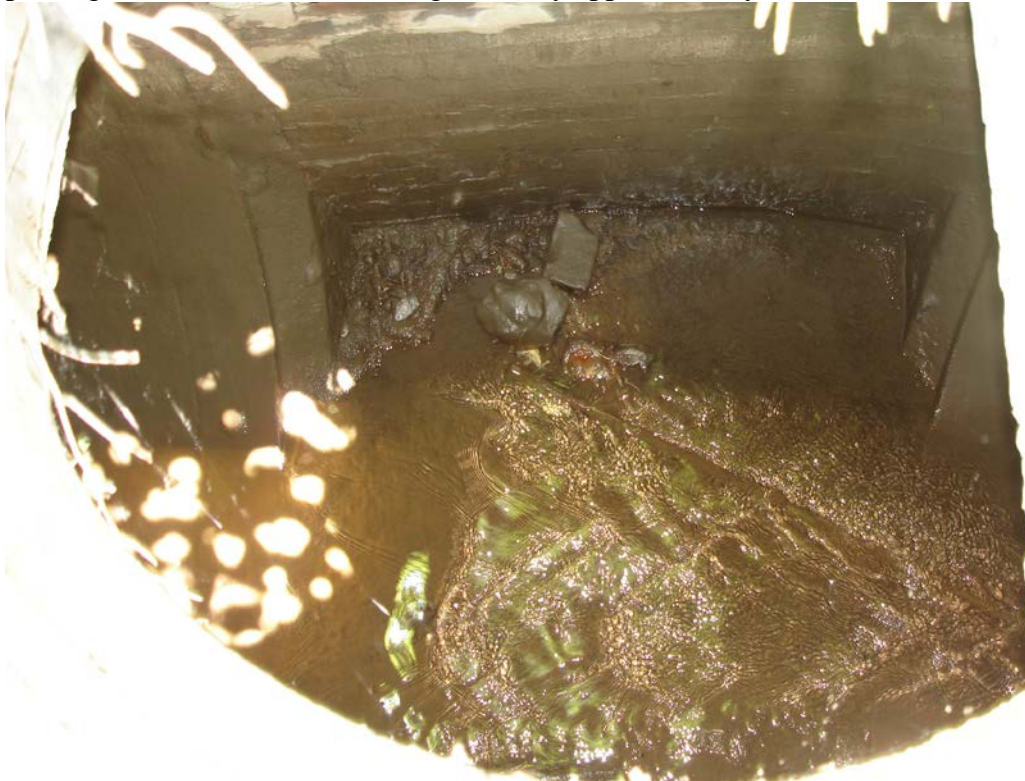
Photo 6: 7/6/11 1144 hrs. View of “GuamRd” sample location, a drain manhole approximately 100 feet northeast of the northern terminus of Guam Road, along the fenceline on the east side of the Chelsea Housing Authority property.

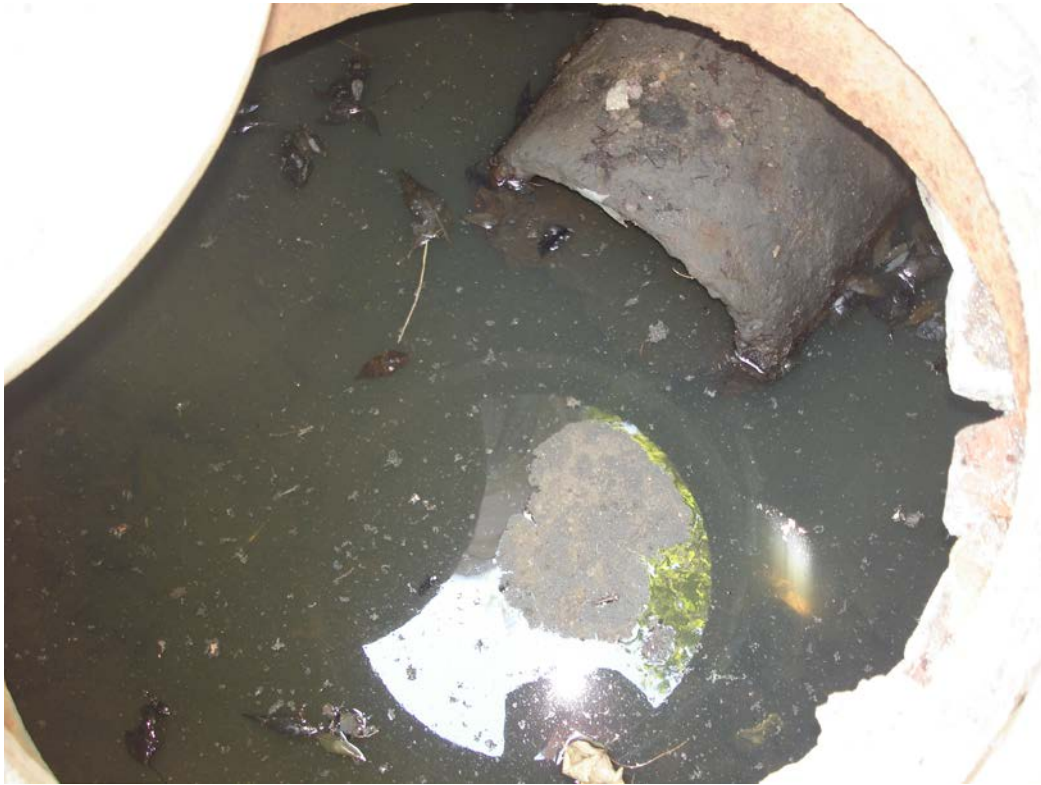
Photo 7: 7/6/11 1209. View of “VokePk” sample location, a drain manhole immediately north of Voke Park, located near an apartment complex dumpster between Annese Street and the Park.

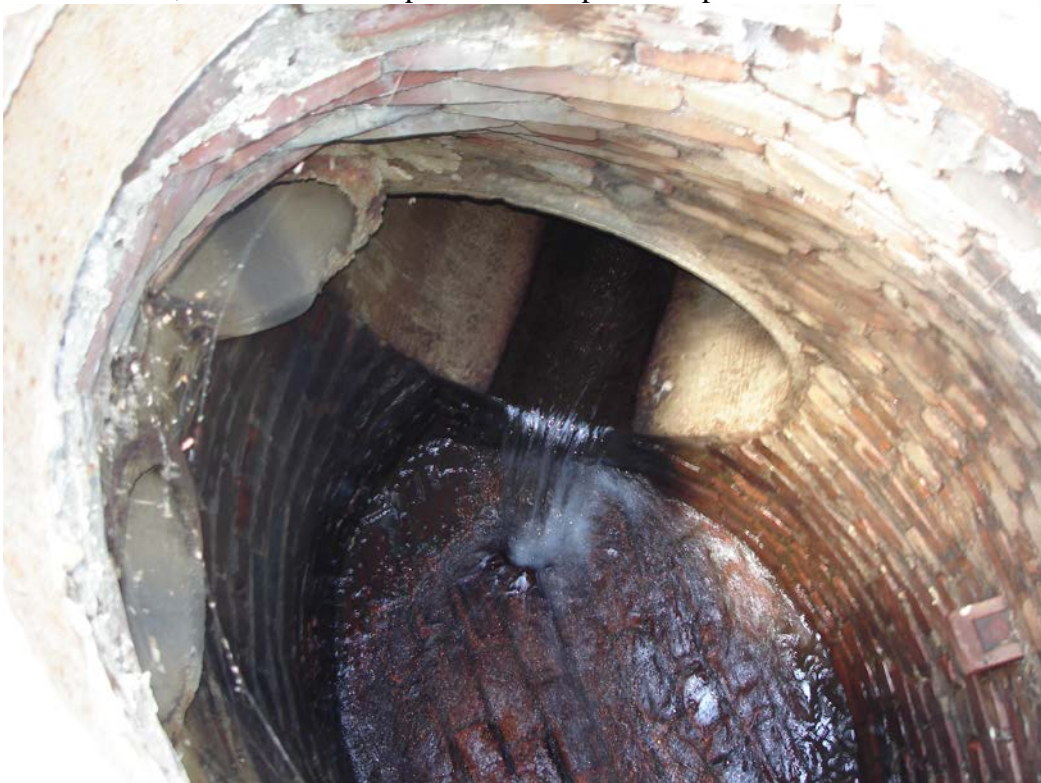
Photo 8: 7/6/11 1230 hrs. View of “SpringV” sample location, a drain manhole at the intersection of Springvale Ave and Brook Street, just SE of the Everett line. The observed flow is from the City of Everett MS4.

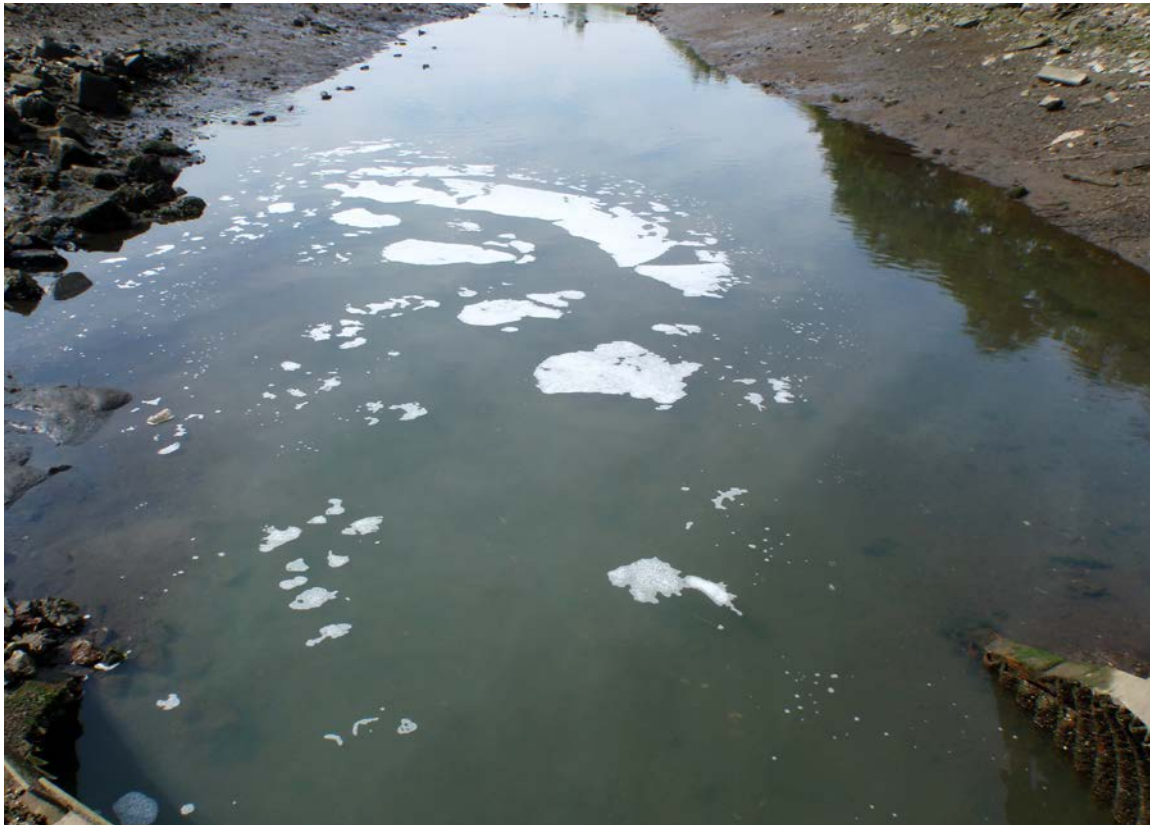
Photo 1: 7/28/09 9:59 AM View facing south – Island End River outfall. Note plume of suds on surface of water. Sample "IsEnd03" collected at this location.

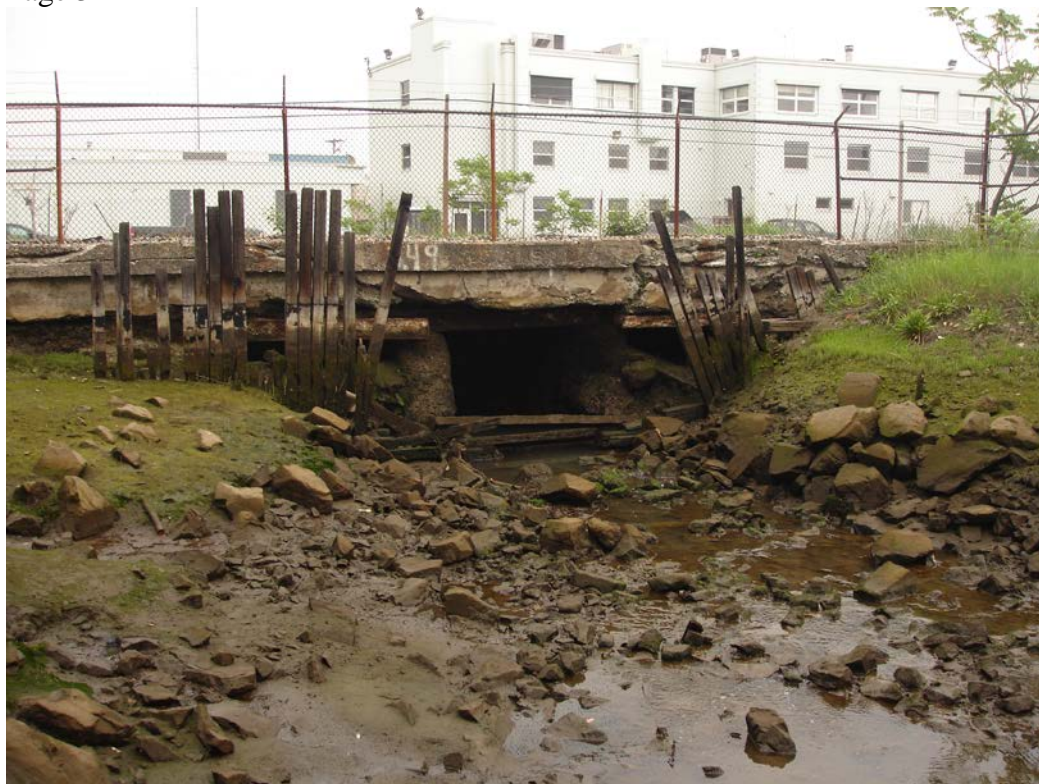
Photo 1: 6/22/11 1113 View of “IsEnd03A” sample location.

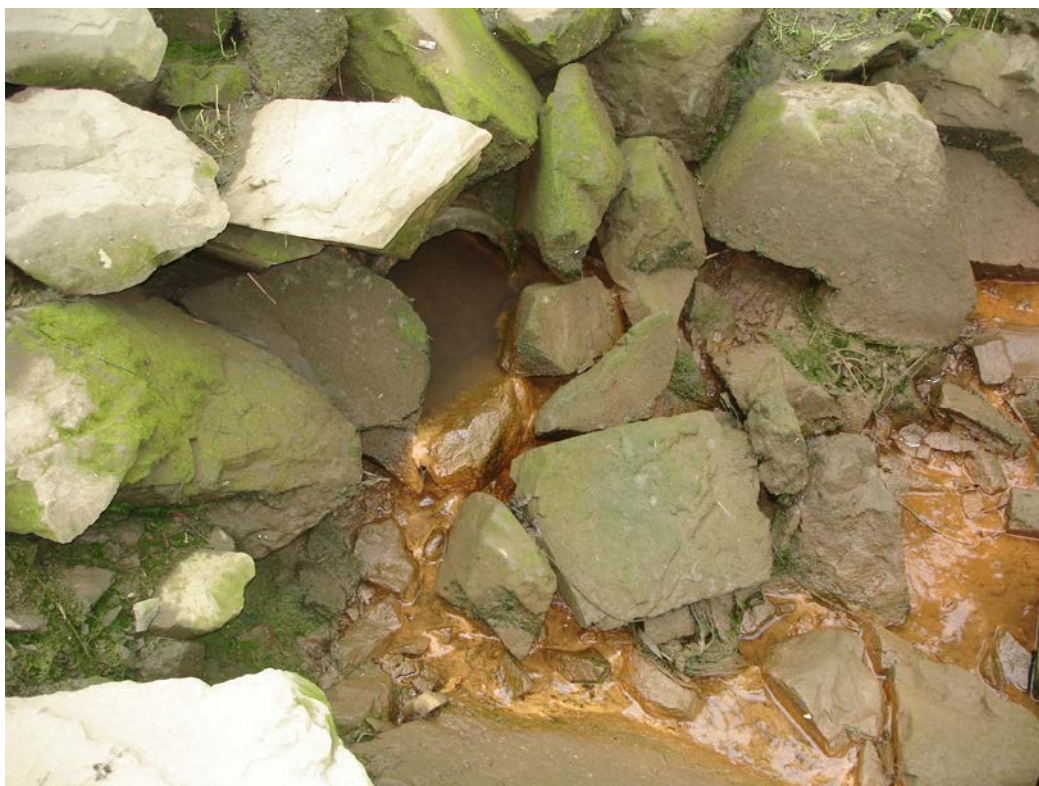
Photo 2: 6/22/11 0950 View of “IsEnd03Z” sample location approximately 50 feet south of “IsEnd03A”. Discharge was murky orange with fine suspended material.

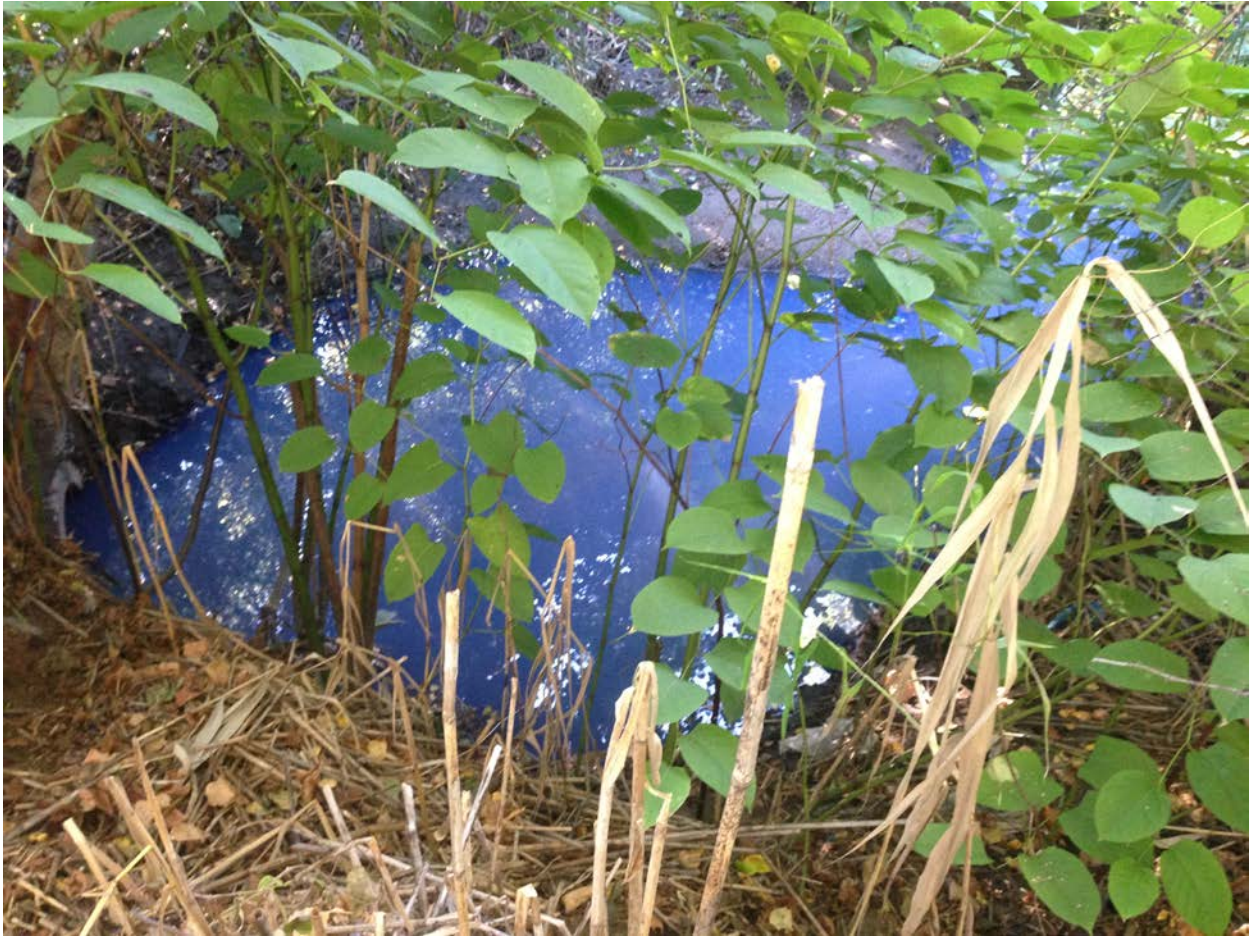
Photo 1: View facing west of Kelvin Street outfall (at far left center) and opaque discharge emanating from outfall.

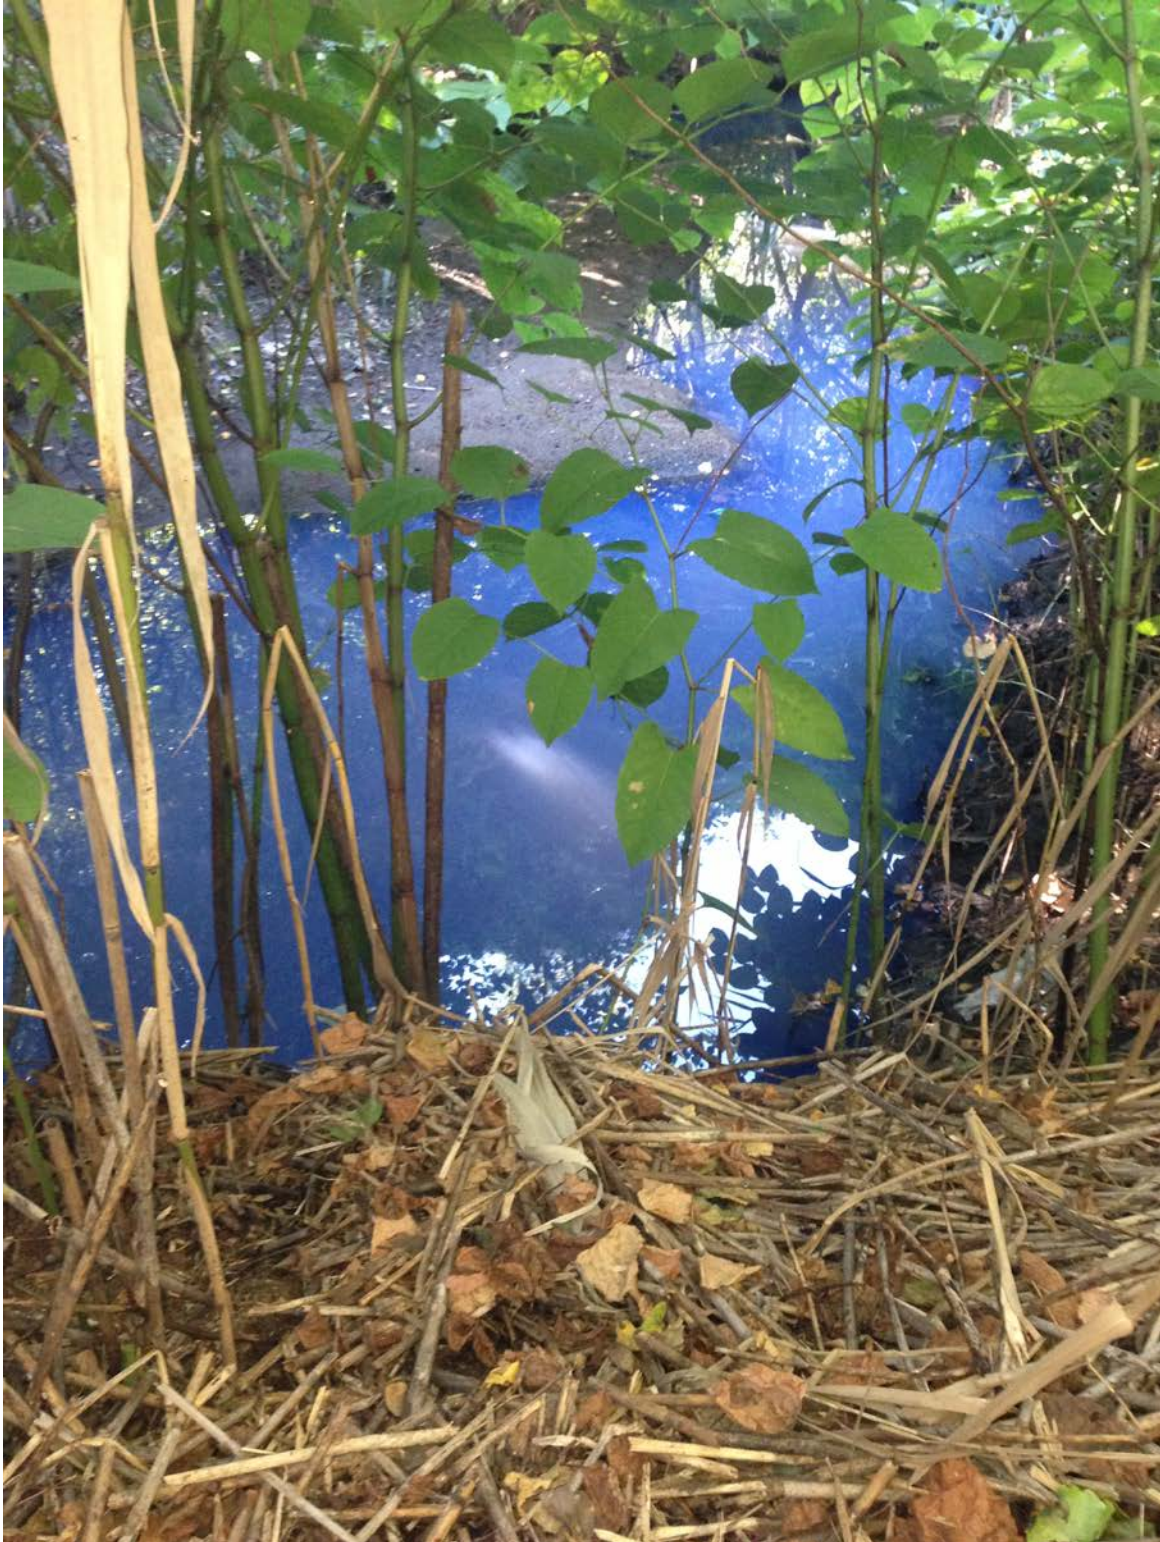
Photo 2: View facing southwest of open channel immediately downstream of Kelvin Street outfall. Outfall seen in Photo 1 is to the left. Milky, opaque appearance is throughout stream.

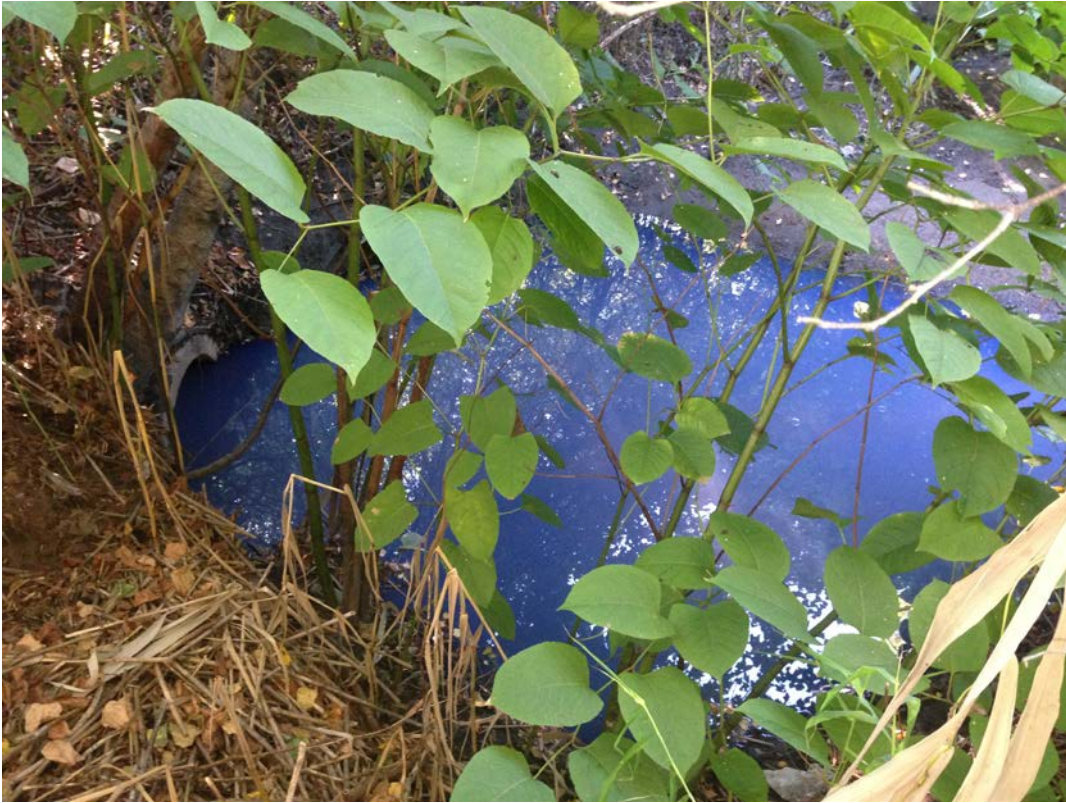
Photo 3: Similar view as in Photo 1; taken to document several large soap bubbles on discharge surface – note bubbles in right center of photo.

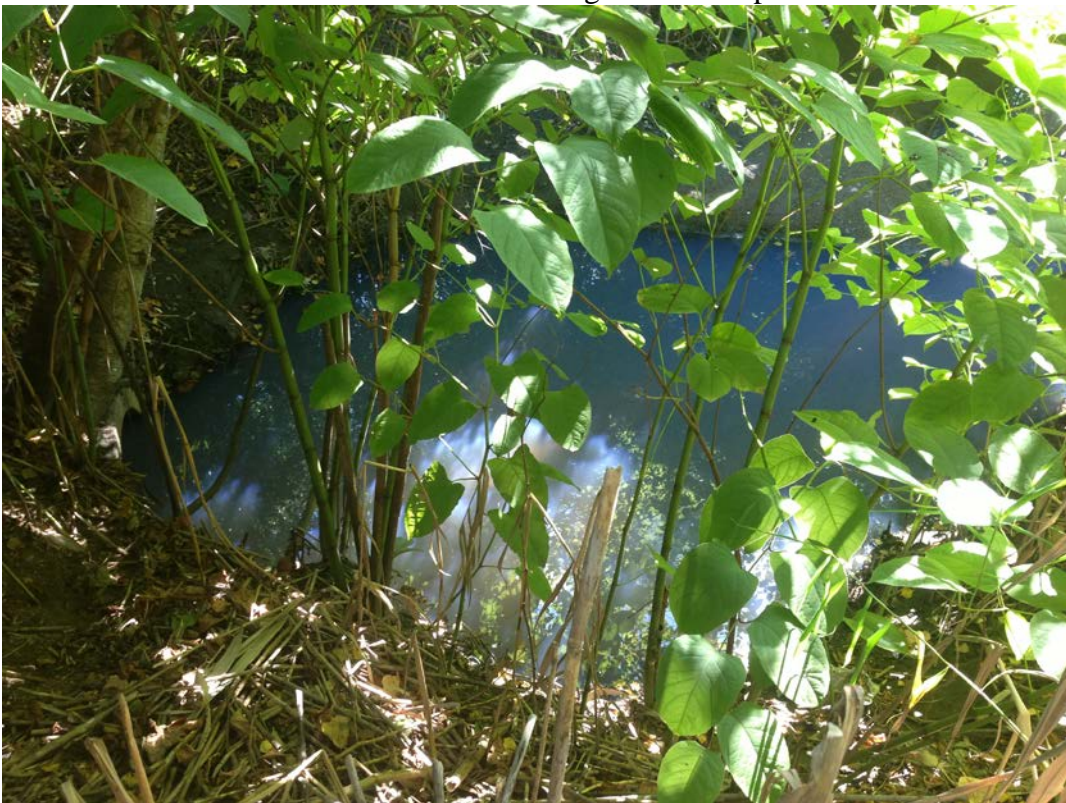
Photo 4: View of Kelvin Street outfall facing west at 12:06 pm. No change in discharge from earlier in the day.

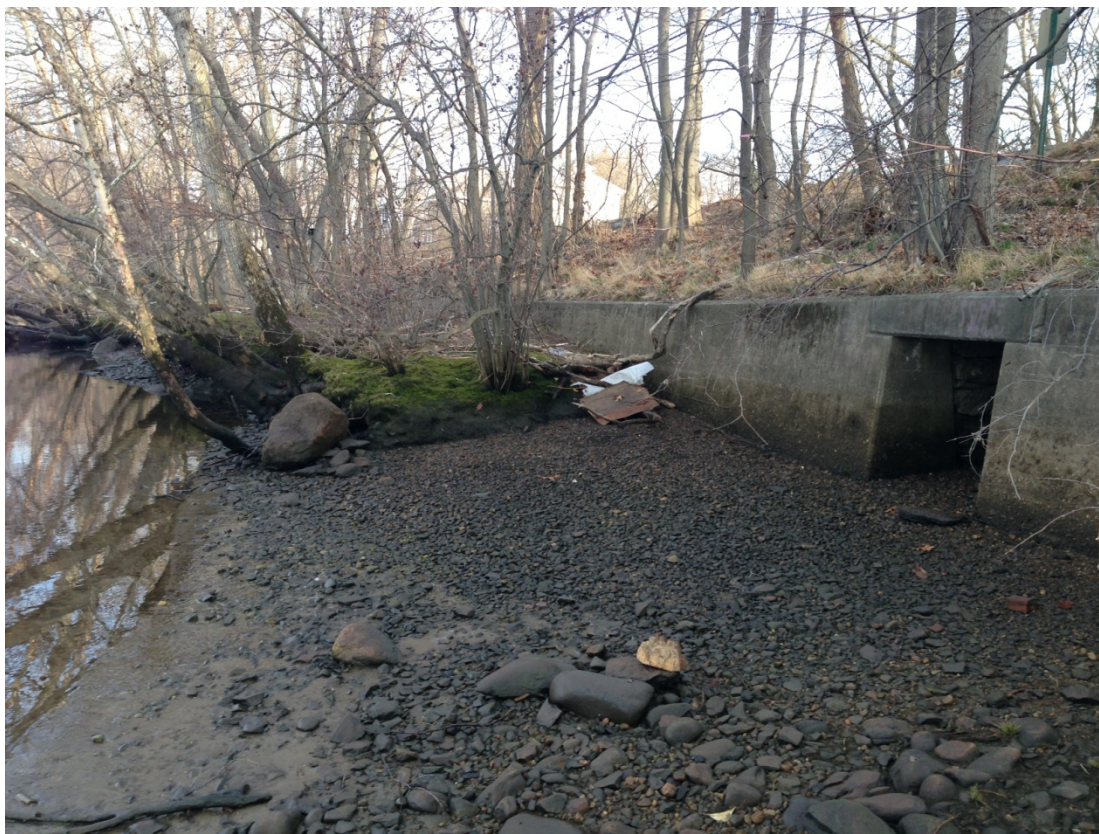
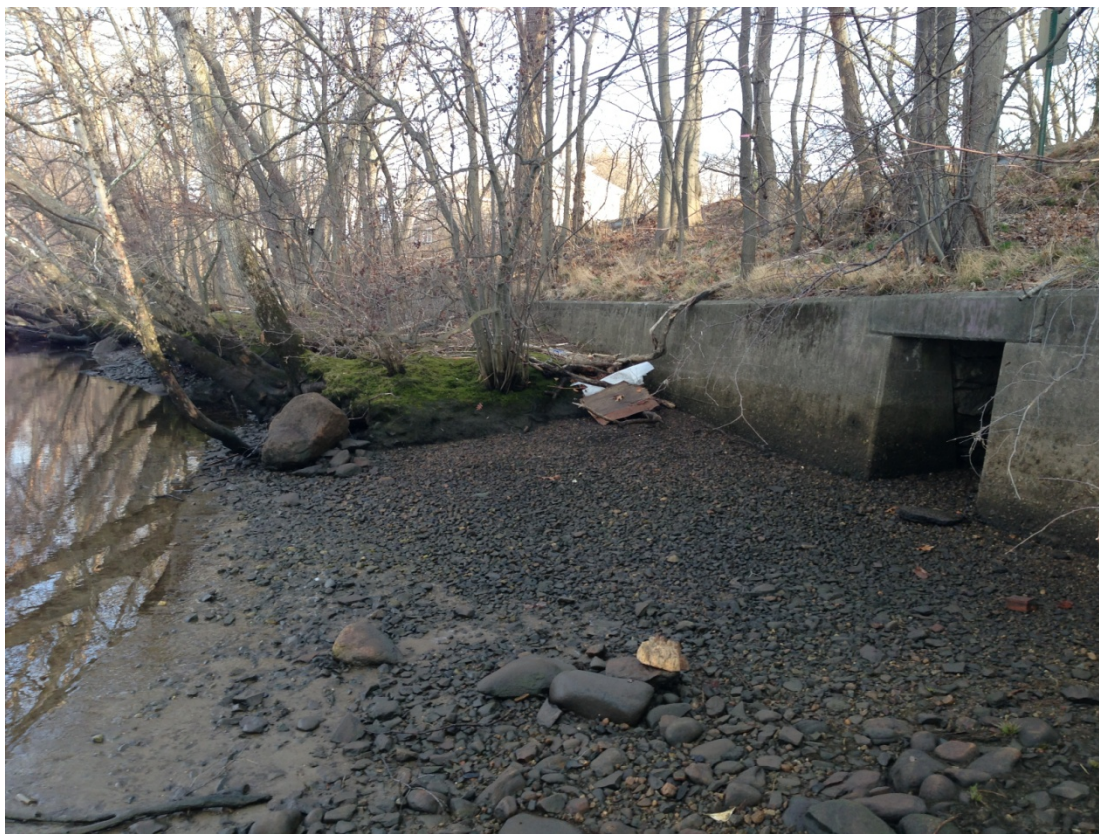
Photo 1: 4/8/13 7:35 am View facing north of CSO #010 near intersection of Water and Boardman Streets. No discharge observed.

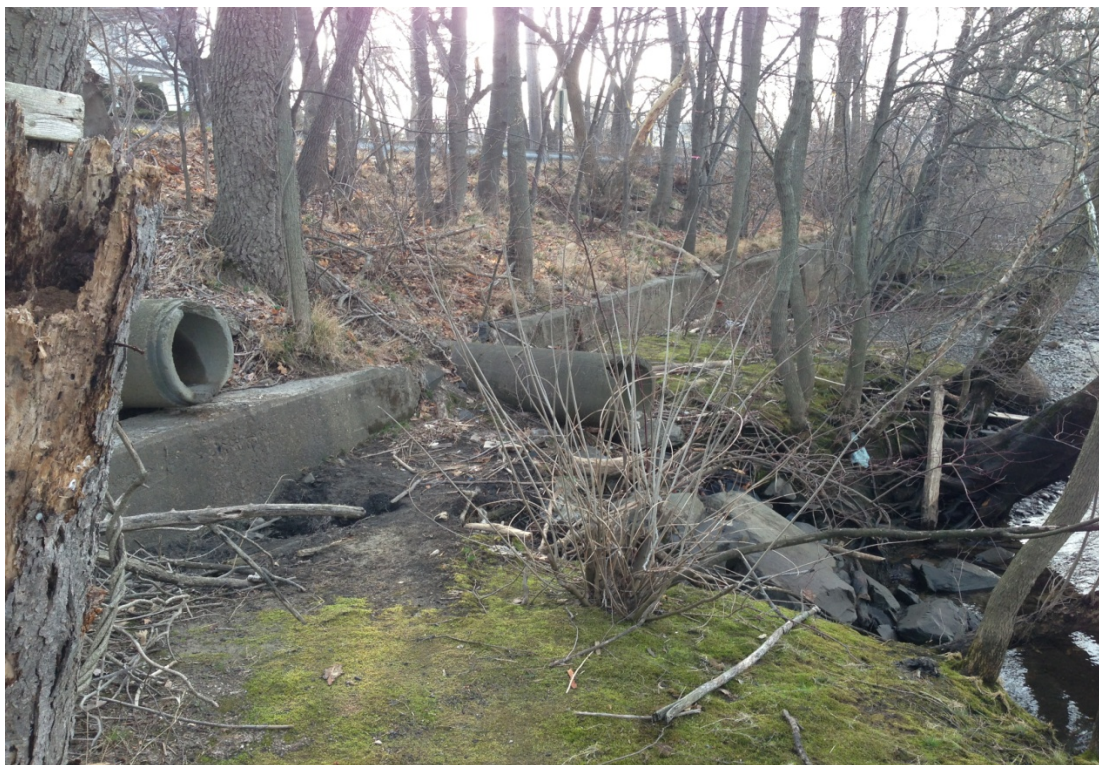
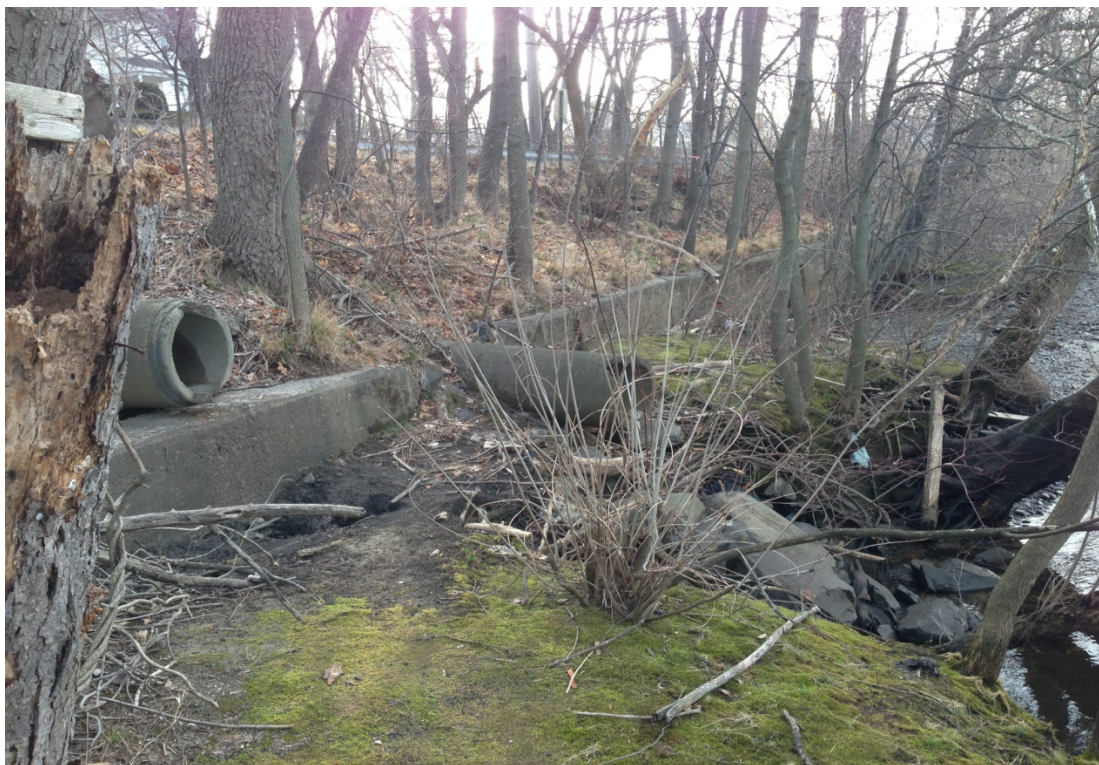
Photo 2: 4/8/13 7:37 am View facing east of two storm water outfalls near intersection of Boardman and Water Streets. No discharge observed.

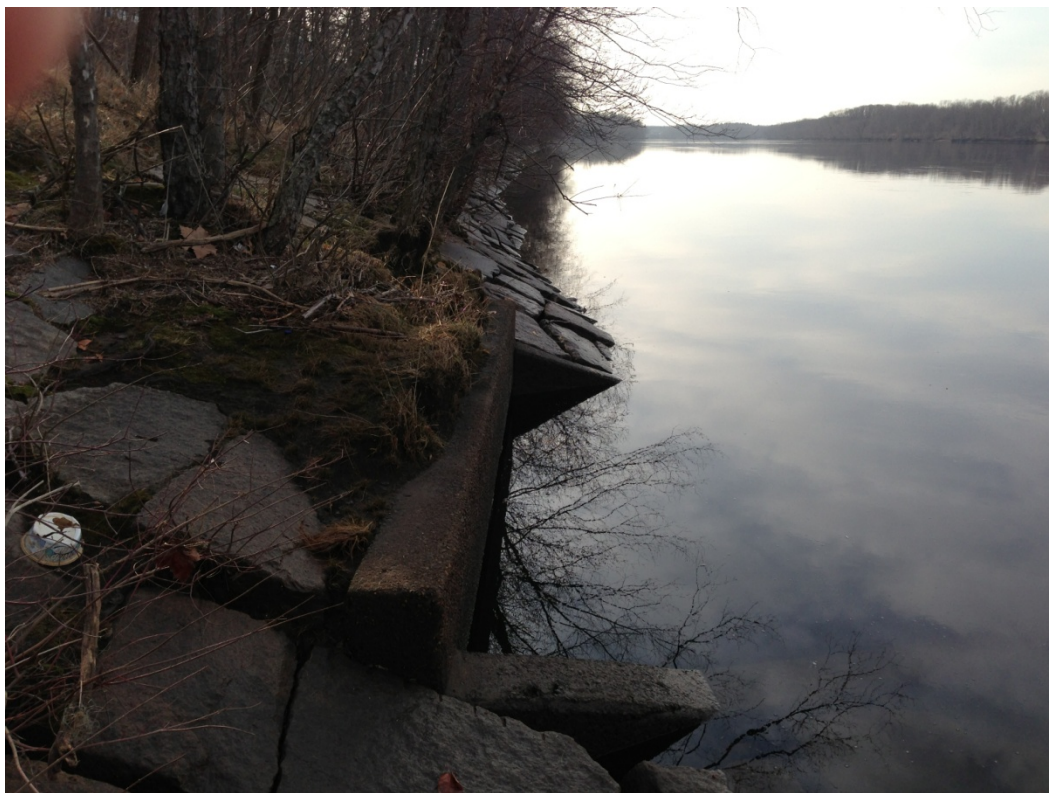
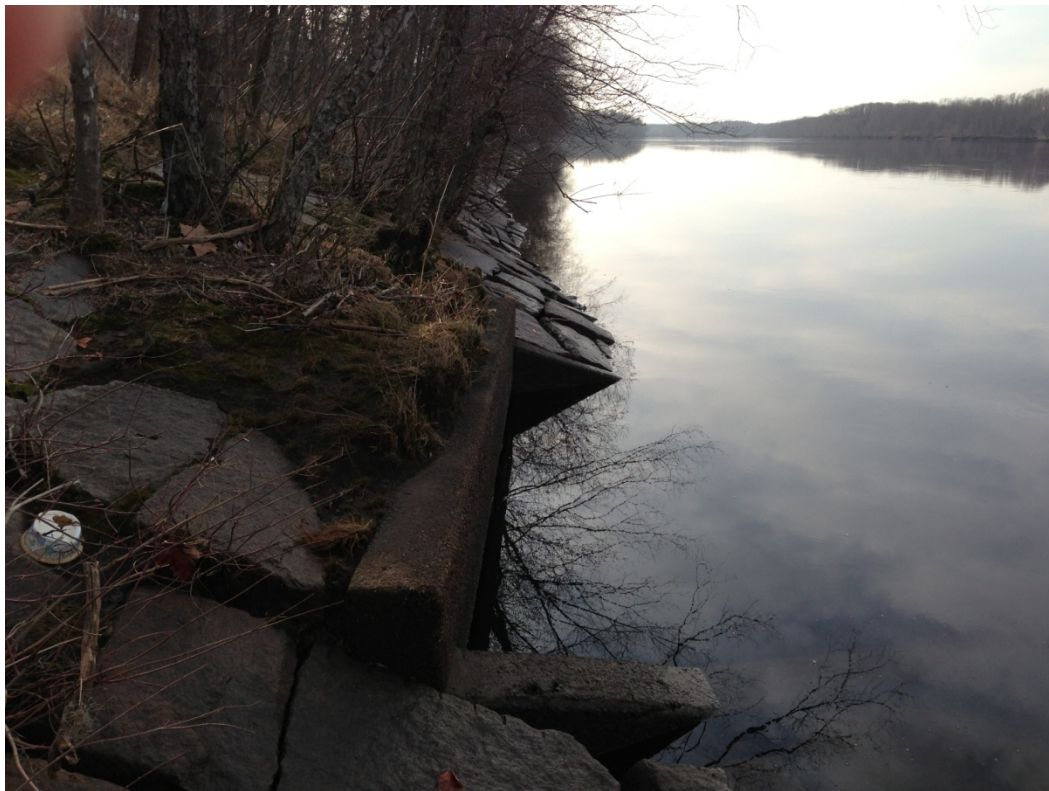
Photo 3: 4/8/13 7:44 am View facing southeast of CSO #013. Outfall almost completely submerged and unable to determine if a discharge occurring.
